W912WJ-10-C-0013 November 2011 JC05

Condition of Unit No. 1 Worthington 119" Hi-Flo Pump, S/N 1596082

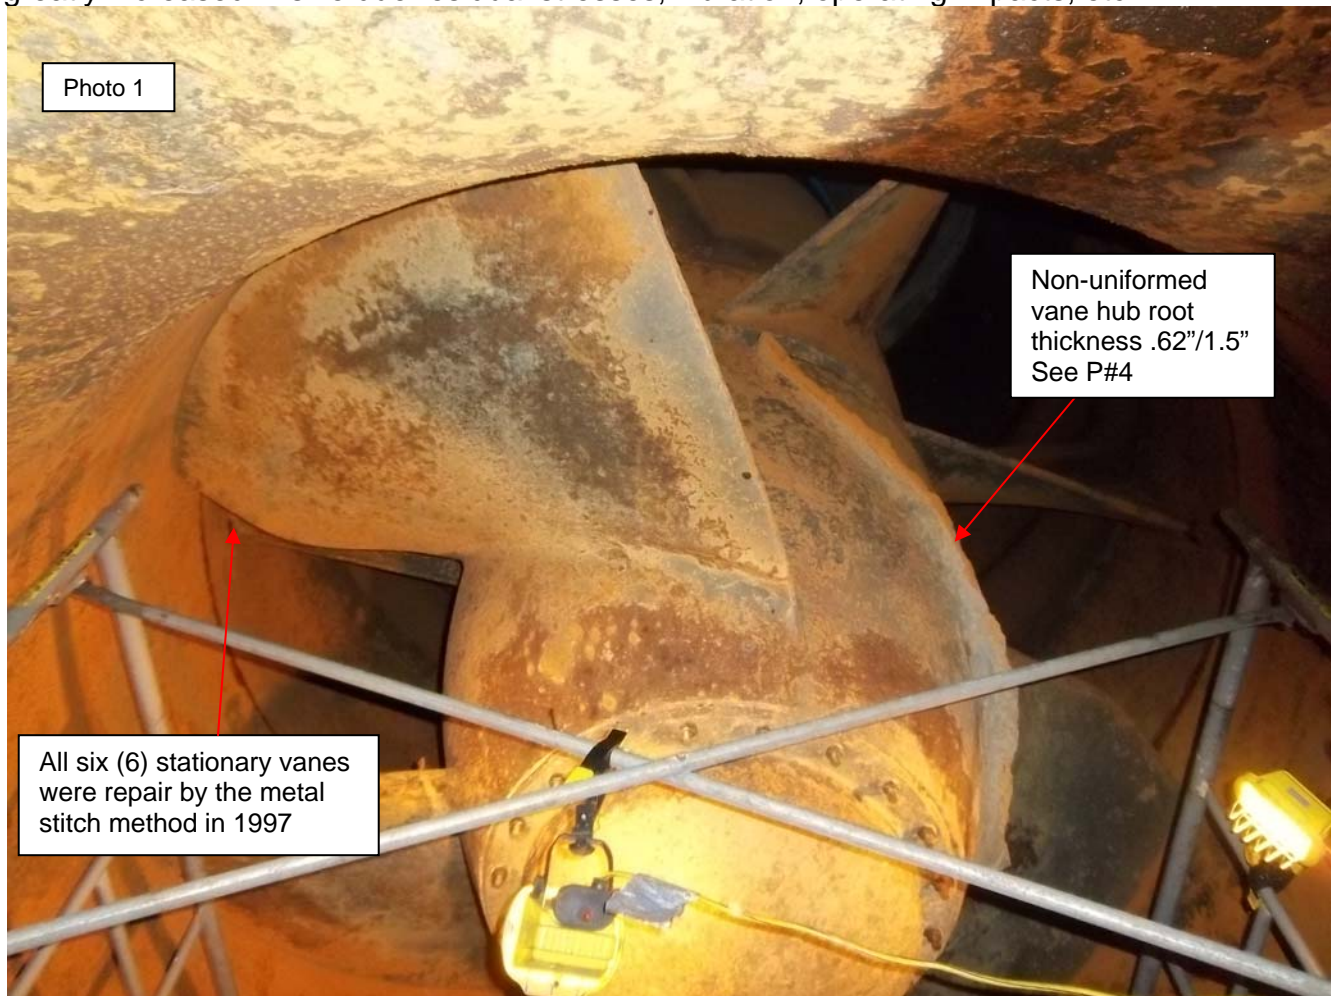
Unit No. 1 Worthington 119"Hi-Flo pump had been operating with a .025" shaft run-out at the upper bearing, this was due to... missing a propeller vane, the main component of the equipment. The 119" diameter impeller weighting 15,000 pounds fractured at one (1) of the four vanes, which completely sheared at the hub. Each vane is approximately 2' wide by 4' long and 1.5" thick, weighing over 600 pounds. The propeller material is a Ni-Resist cast iron, high nickel content (18-22%) which other than the mechanical damage is still in excellent condition after being submerged in brackish water for over forty (40) years.

The propeller vane cracking is attributed to the type of material (NiResist Type 1b) used back in the early 60's, which did not posses enough ductility (brittle), and had long graphite flakes. Over a long period of time in usage, the many small micro-cracks in the original casting structure have greatly increased in size due residual stresses, vibration, operating impacts, etc.

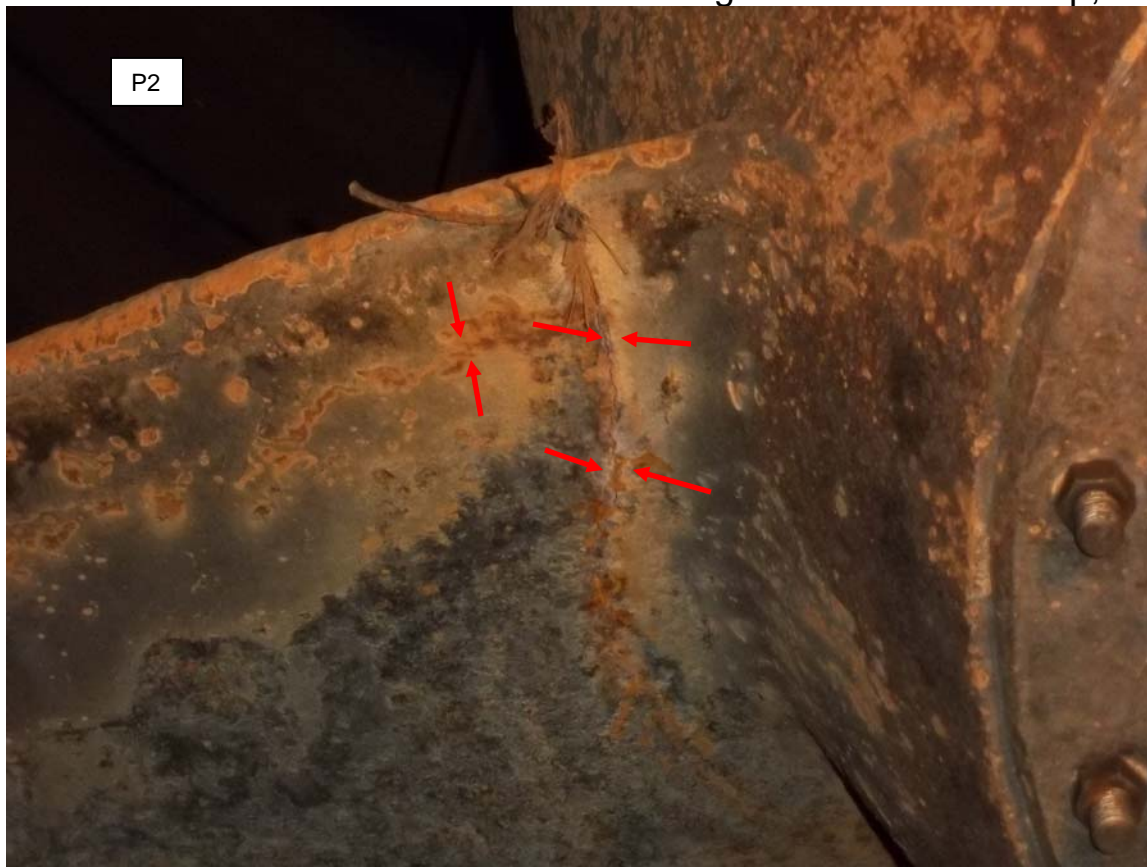
Attributing failure mode...to the original material problem, we believe there was a latent defect in the casting portion of the vanes. It is not known whether this was a problem with the original hand sketch type drawings from the early 1960's before CAD was developed and then transposed into the last propellers provide in 2001 and 2005. The leading vane hub root area varies from .62" to 1.75" thick, where-as the vanes have an overall thickness of 1 .5"/2.0". This a relatively thin area at high stress point, which probably had micro cracking when originally poured due to rapid cooling at this area.

Note the remaining blades are cracked at the root area

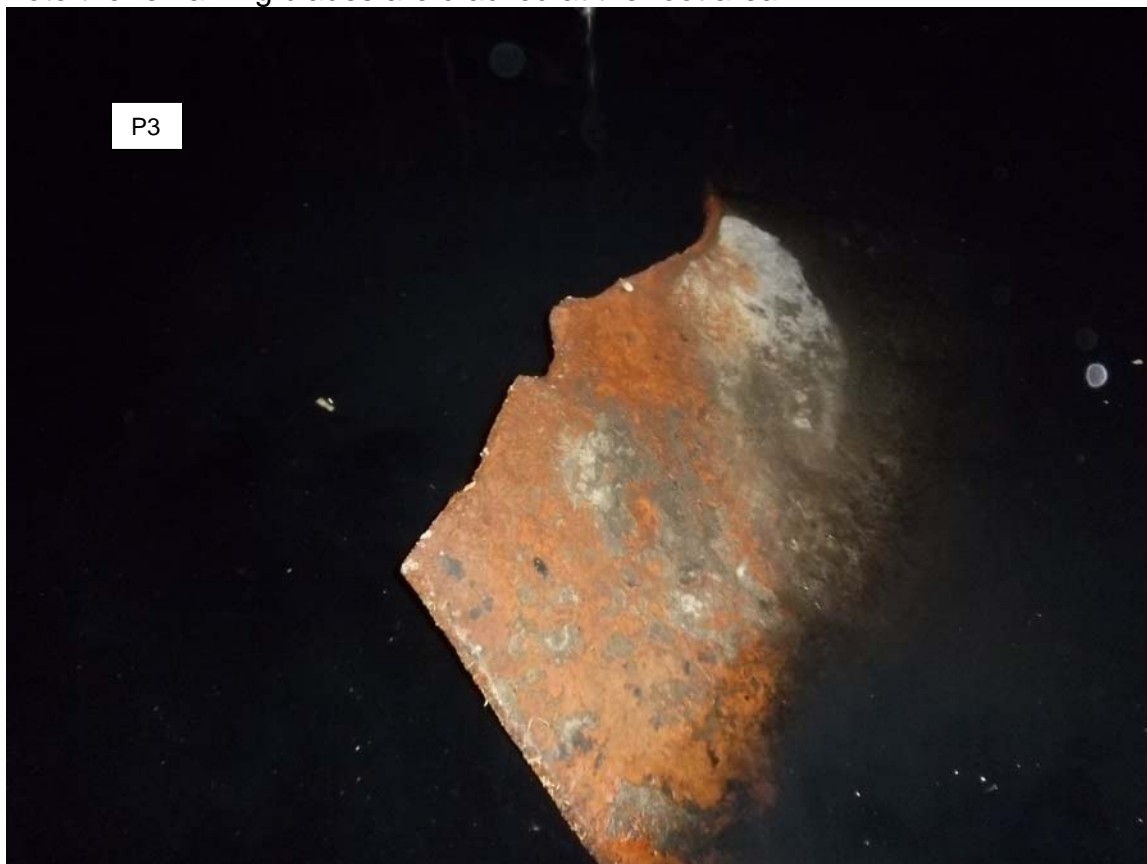
Figure 8.0

Broken blade found to the right of the suction intake area

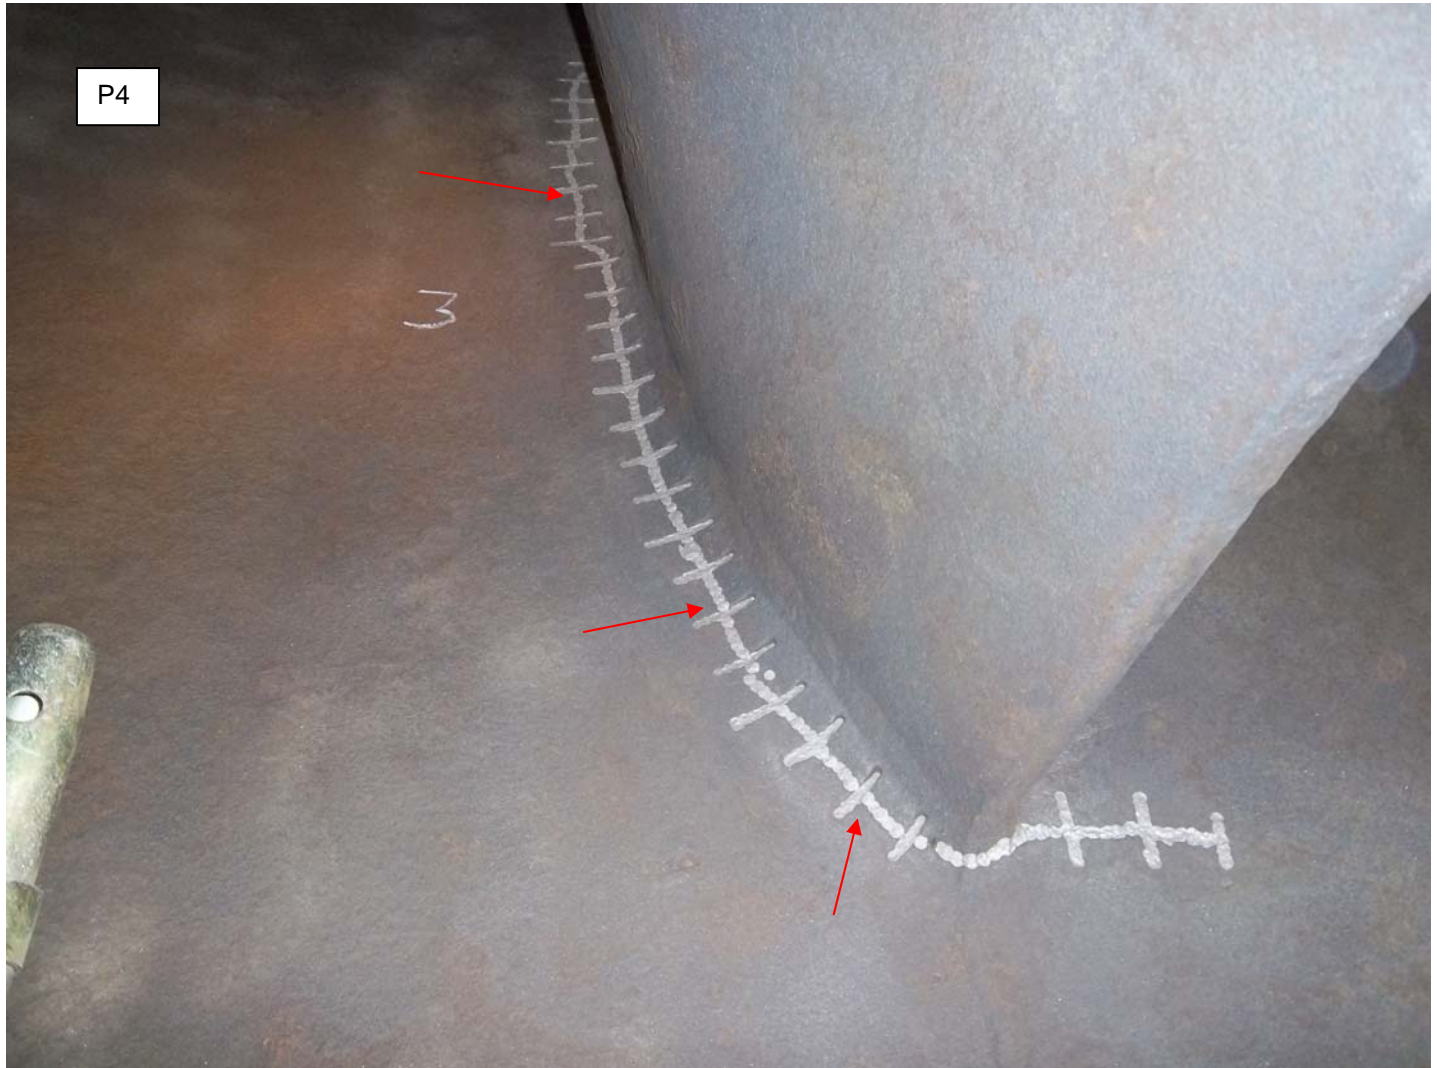
Twenty-four feet of cracks to the stationary diffuser vanes... were repaired by the metal stitch method in 1997. The stationary diffuser guide blades for straightening the water flow from the impeller were crack on the backside. Each of the six (6) vanes had approximately 48 inches of linear indications at the hub root area outer perimeter, totaling 24 feet. These vanes also provide support for the lower bearing housing assembly and enclosing covers/columns. The fractures in the diffuser vanes are a typical occurrence on these units. Inspection revealed another 15 feet of various cracks, mapped on the **Diffuser Inspection Report**

Previous metal stitching repair in excellent condition of a 48" crack, typical for each vane

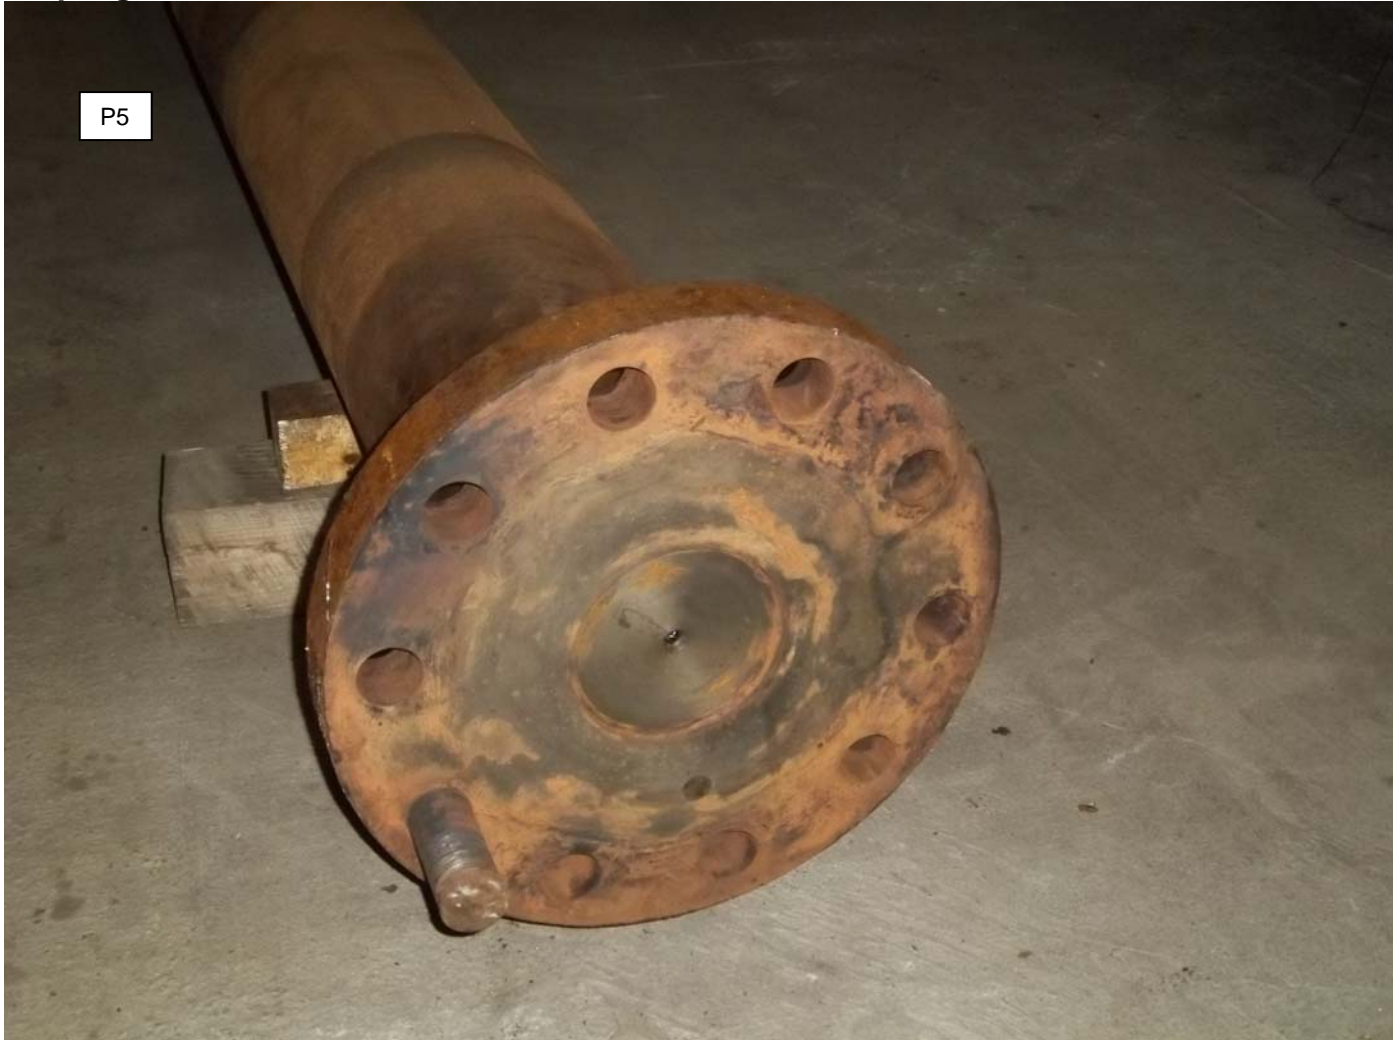
Note: During the disassembly several of the bolts had to be cut and most were galled to the nuts requiring heating and Hytorc Wrench for removal. Remnant of bolt lodged in the coupling hub.

- Coat exposed areas with Cosmoline Rust Veto 342 rust protector.
- Furnish ten (10) new coupling body bolts with castle nuts
- Ream each bolt location and fit the new bolts and match mark

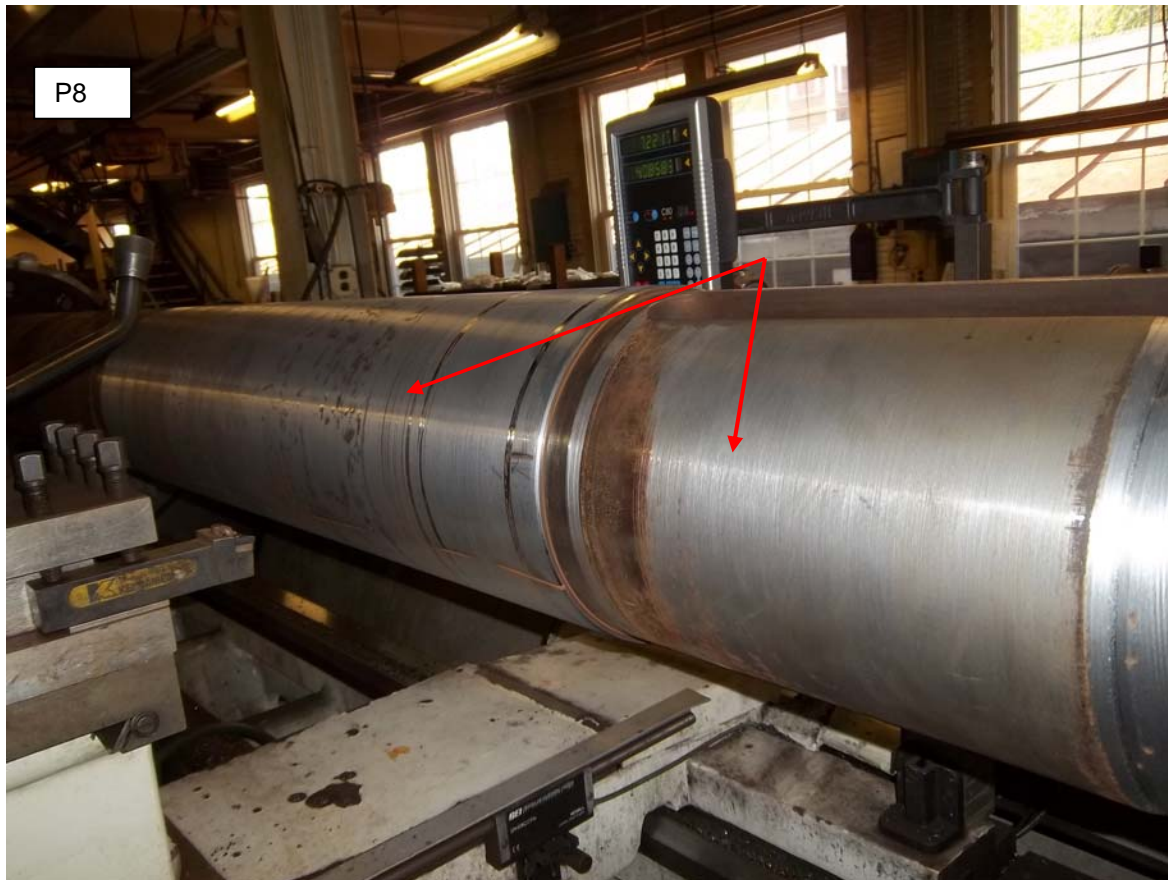
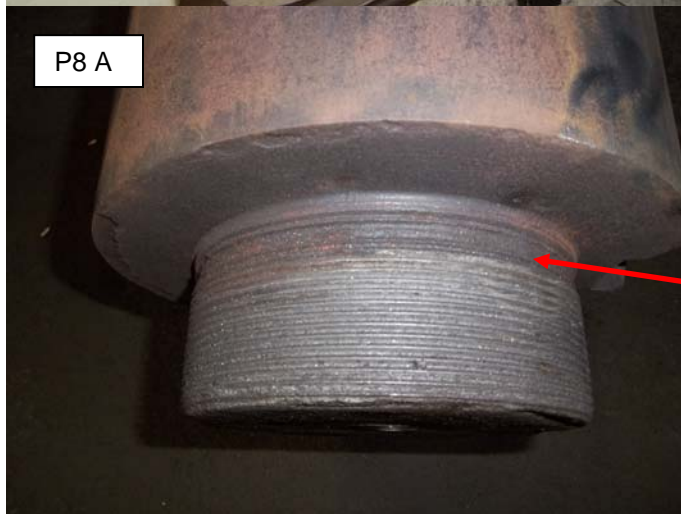
7.3.2 The lower shaft (12'L) was setup and checked for conformance to our drawing (**AP-119-REF2**) . TIR within .002". The propeller fit areas are eroded and undersized .010" (**Ref Figure 8.2**) The threads for the coupling nut are have been compromised from corrosion at the base area, but should be acceptable for the next cycle. NDT by ultrasonic testing was acceptable (**Ref Mistras Reports**)

Threaded section for the propeller nut are slightly eroded at the shoulder area, acceptable the next cycle of operation

- The propeller fit diameters be skim cut undersized by .030" and compensated in the new propeller bore to allow for .002"/.004" clearance
- Furnish and fit two new propeller keys

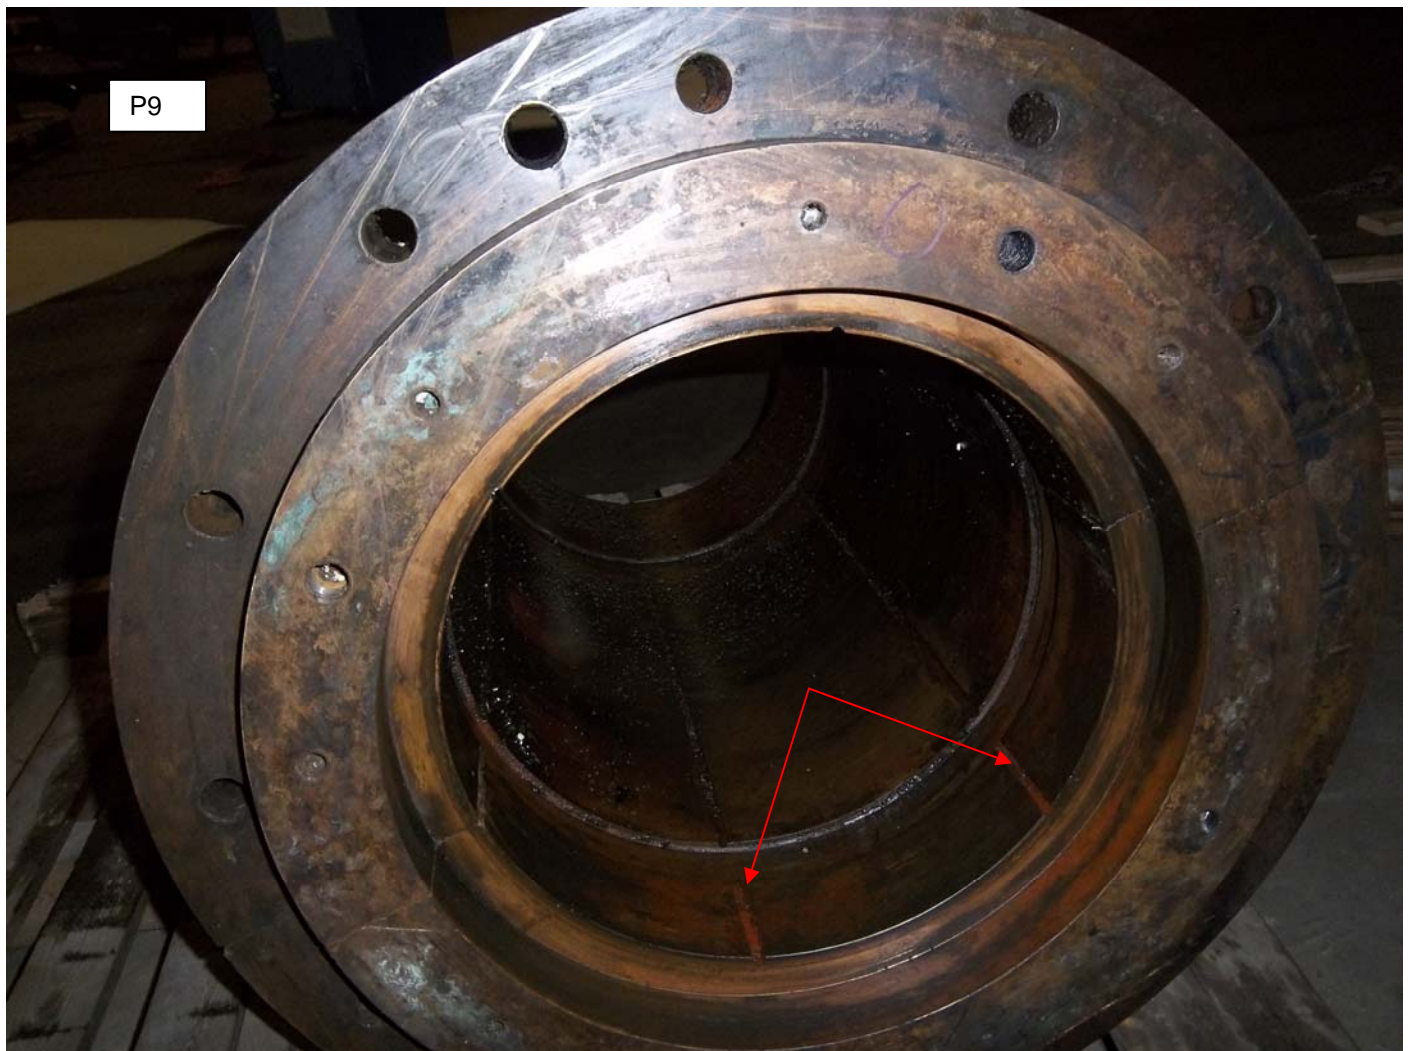
7.3.3 Upper/Lower Bearings and Sleeves... have been removed and cleaned for inspection. The lower bearing is the original design with limiting lubricating and is scored due to lack of lubrication along with the lower journal sleeve. The lower sleeve will be replaced under contract in Monel 400 material per our drawing (**AP-119-REF10**)

Diametrical running clearance of the sleeve to the bushing .033"/.042" (**Design .020"/.022"**)

Original style lower bearing experience poor lubrication, which resulted in over heating
Note lack of lubrication on surface

- Contractually the lower bearing will be upgraded per our drawing (**AP-REF119-57**) which increase the lubrication grooves to $\frac{3}{4}$ ".

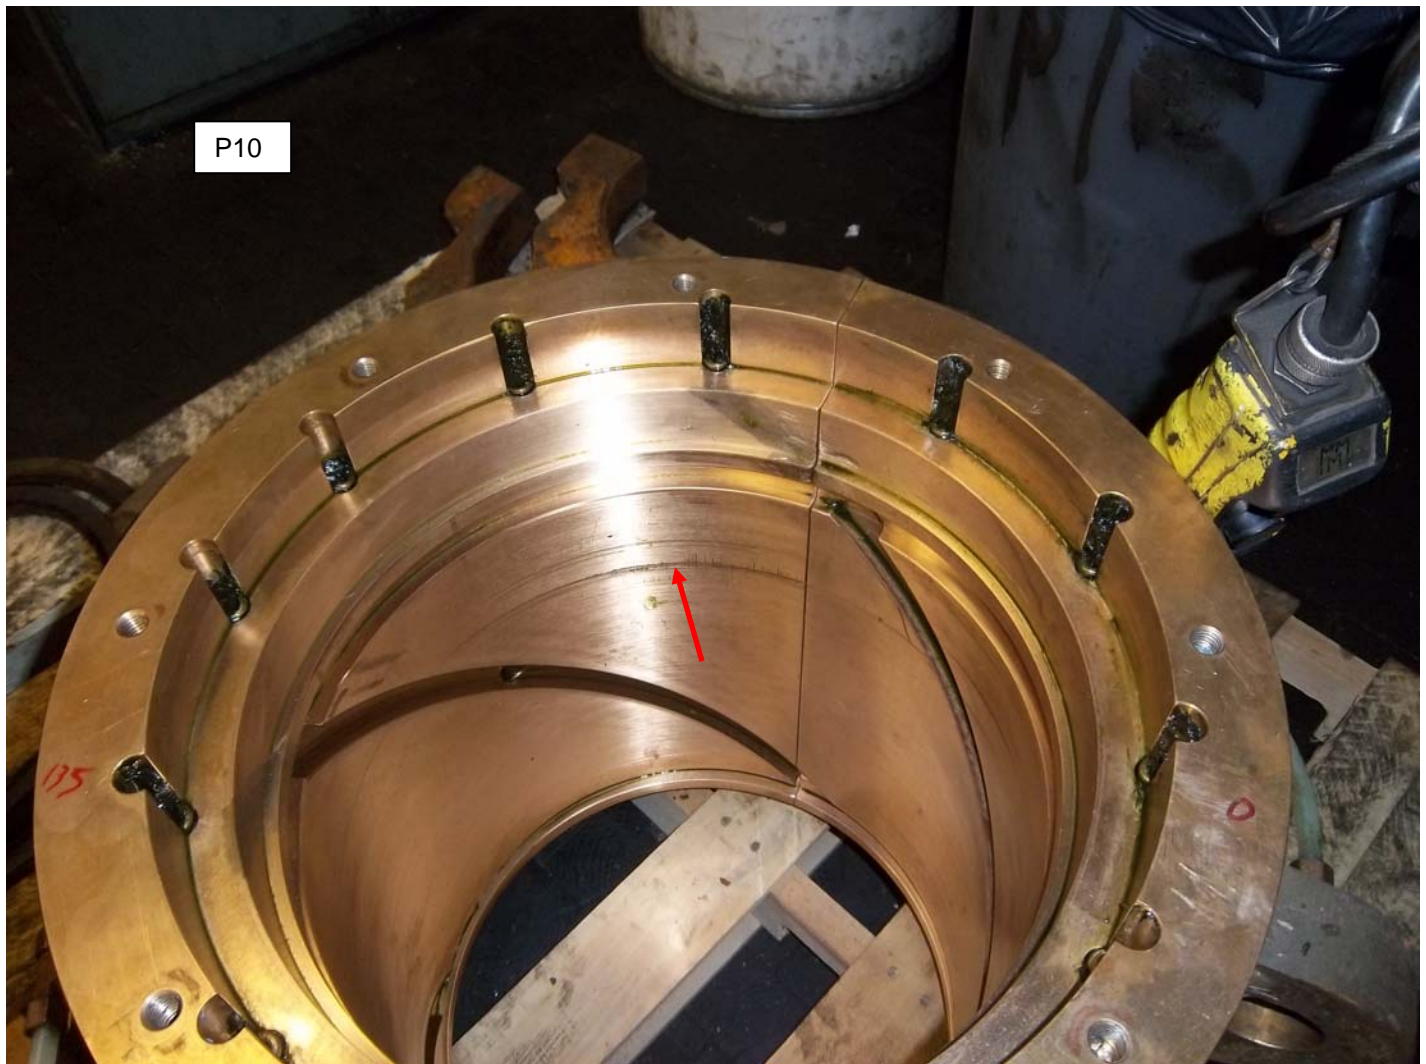
The upper bearing is in fair condition with some scoring, and is of the new design, which incorporates the larger grease grooves and water cooling jacket, per our drawing **(AP-119-57A)**

The upper journal sleeve is score and grooved at the seal areas and will be replaced as per the contract in 420SS per our drawing **(AP-119-REF-10A)**

Diametrical running clearance of the sleeve to the bushing $.027"/.033"$ **(Design $.020"/.022"$)**

- The upper bearing be re-machined, to remove score marks open the bore to $13.525" +.002"/-.000"$
- Charge the cooling jacket with water and check for leaks
- Re-establish the clearance of $.020"/.022"$ with the new journal sleeve.
- Replace the two (2) upper and the two (2) lower lip seals
- The upper shaft sleeve will be increased in diameter to $13.505" +.000"/-.002"$

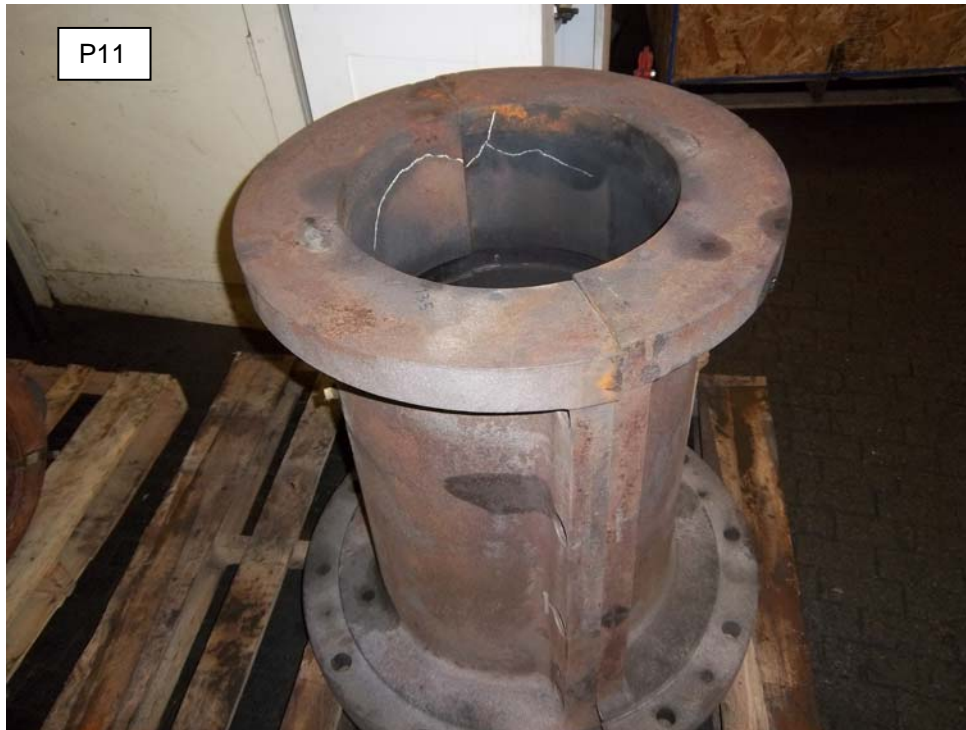
7.3.3 Lower Bearing Bracket... for mounting the lower bearing bushing and centralizing in the diffuser is in poor condition with spider cracks on both halves in the bottom area. Note previously metal stitched at other areas. Dimensional readings shown on **(Figure 8.3)**

Note the hardware was carbon steel was severely corroded.

- Furnish a new bearing bracket in Ductile Ni-Resist cast iron.
- All hardware for securing to the bearing frame be replaced in 316SS. .
- Replace the two (2) lip seals and the retainer plates with new 316SS hardware.

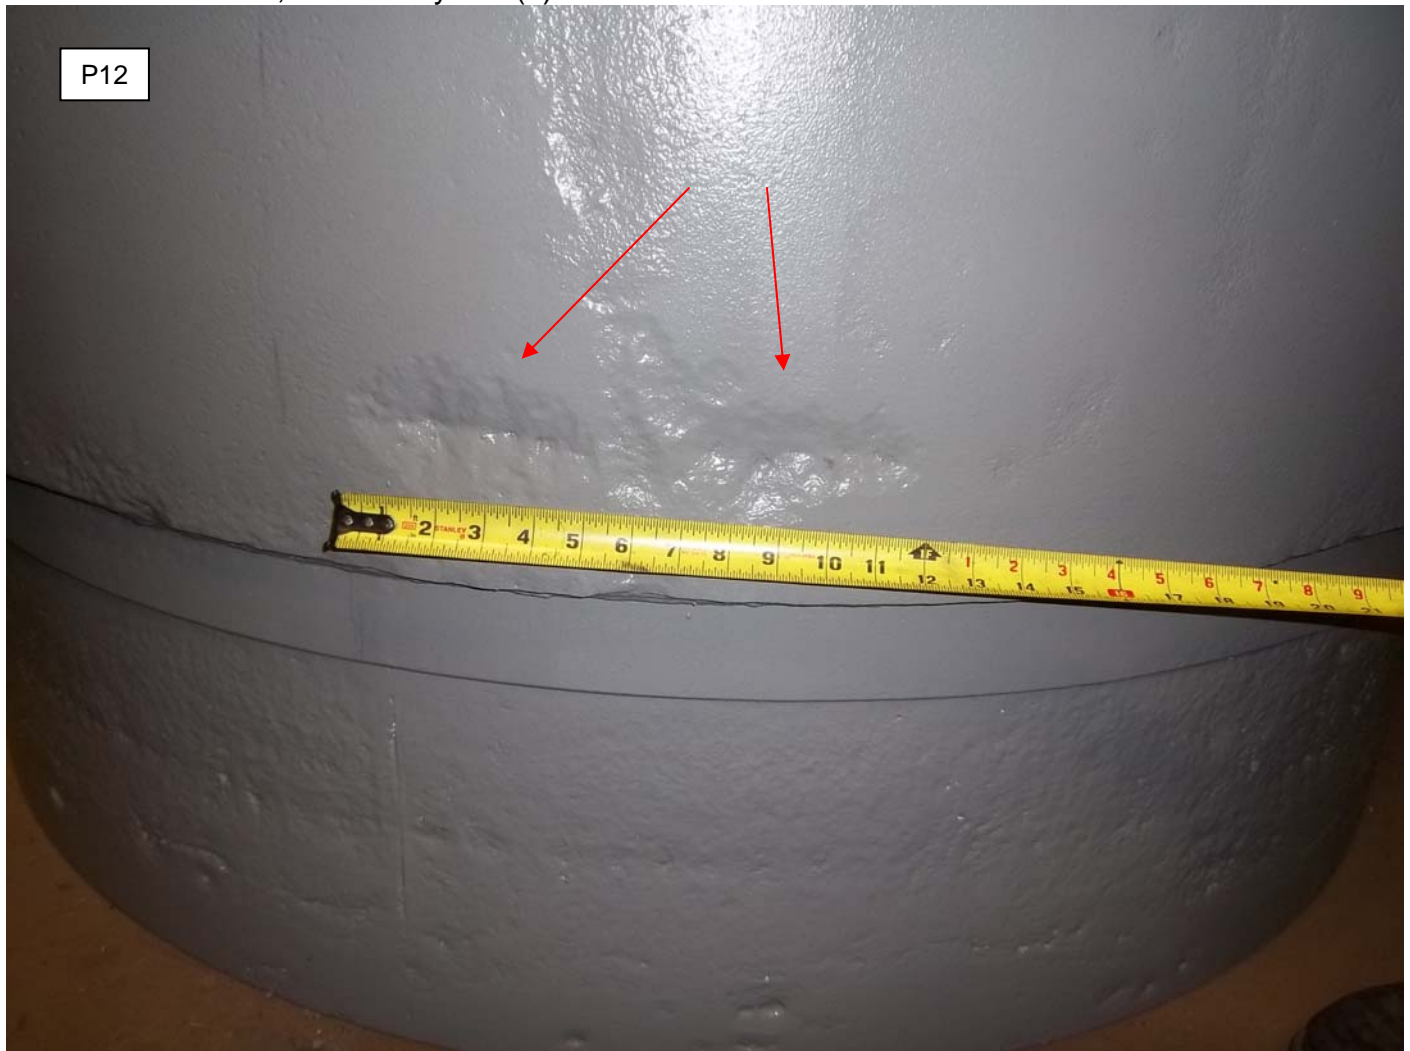
7.3.4 Inner columns and bearing covers in fair condition...after sandblasting the upper/lower shaft enclosing columns and split bearing chamber covers, all components were found in fair condition. The upper column is reusable as-is. The packing gland constructed of 300 series stainless and is in good condition. The split cover casting assembly is in good condition. The lower column expansion joint which seals between the split covers has some deteriorated and allowed water into the bearing chamber. The lower column has numerous deep (1/2") pits and should be replaced.

Lower Column typical of some deep pits

- The split covers be cleaned and painted with One coat Rust Bond LT to 1-2 mils DFT, followed by two (2) coats of 890 LT 16- 20 mils DFT total.
- Furnish a new packing gland in 316L material as per our drawing (**AP-119-REF-15**)
- Furnish a complete set of 316SS hardware.
- The lower column should be replaced completely new in carbon steel per our drawing (**AP-119-REF-51A**) Coating System as manufacture by Carboline Co. One coat Rust Bond LT to 1-2 mils DFT, followed by two (2) coats of 890 LT 16- 20 mils DFT total.

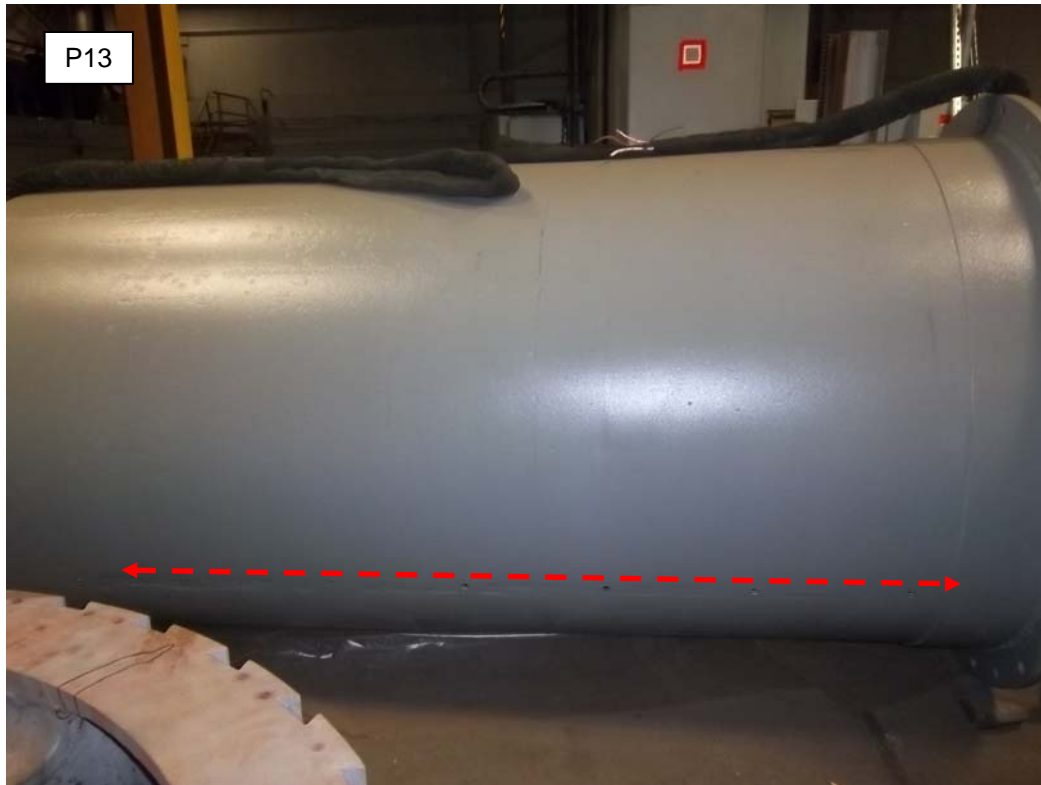
Upper Column good condition, cleaned and painted with Carboline System

Guide key location, carbon steel keys to be replaced with Nitronic material

Upper column to be re-blasted for SSPC-SP 10 surface profile and painted with Carboline coatings systems. Contractually furnish and install two (2) Nitronic 60 guide keys for the backwater water closure

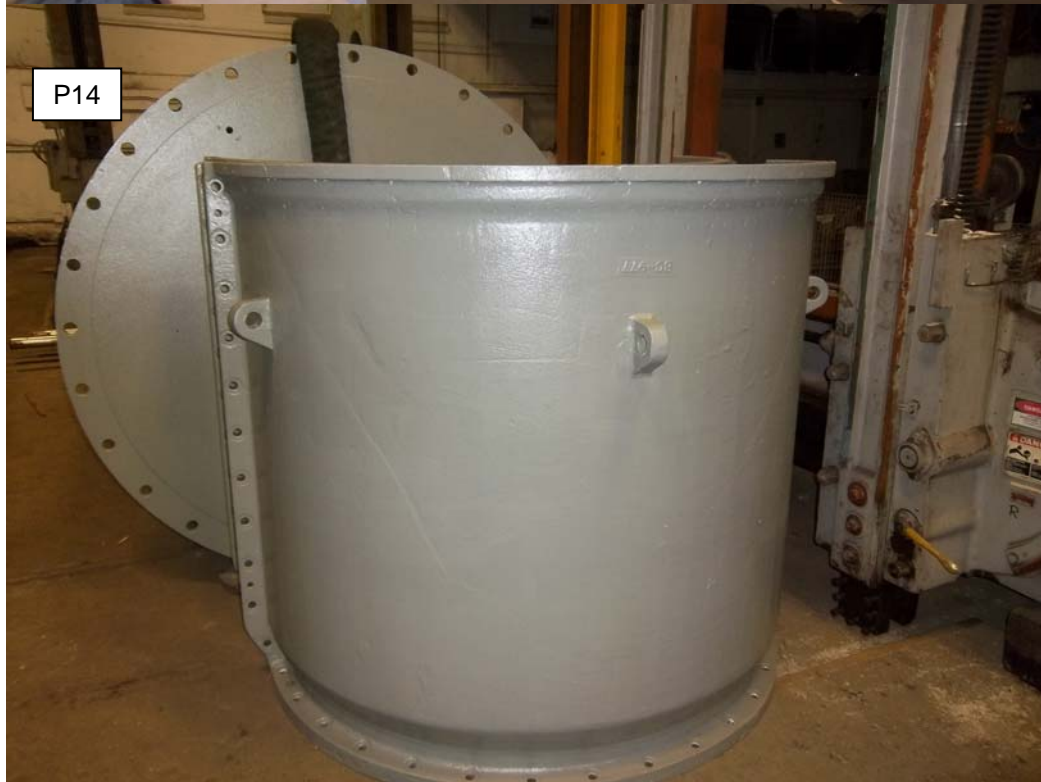
Lower split covers in good condition, cleaned and painted with Carboline System

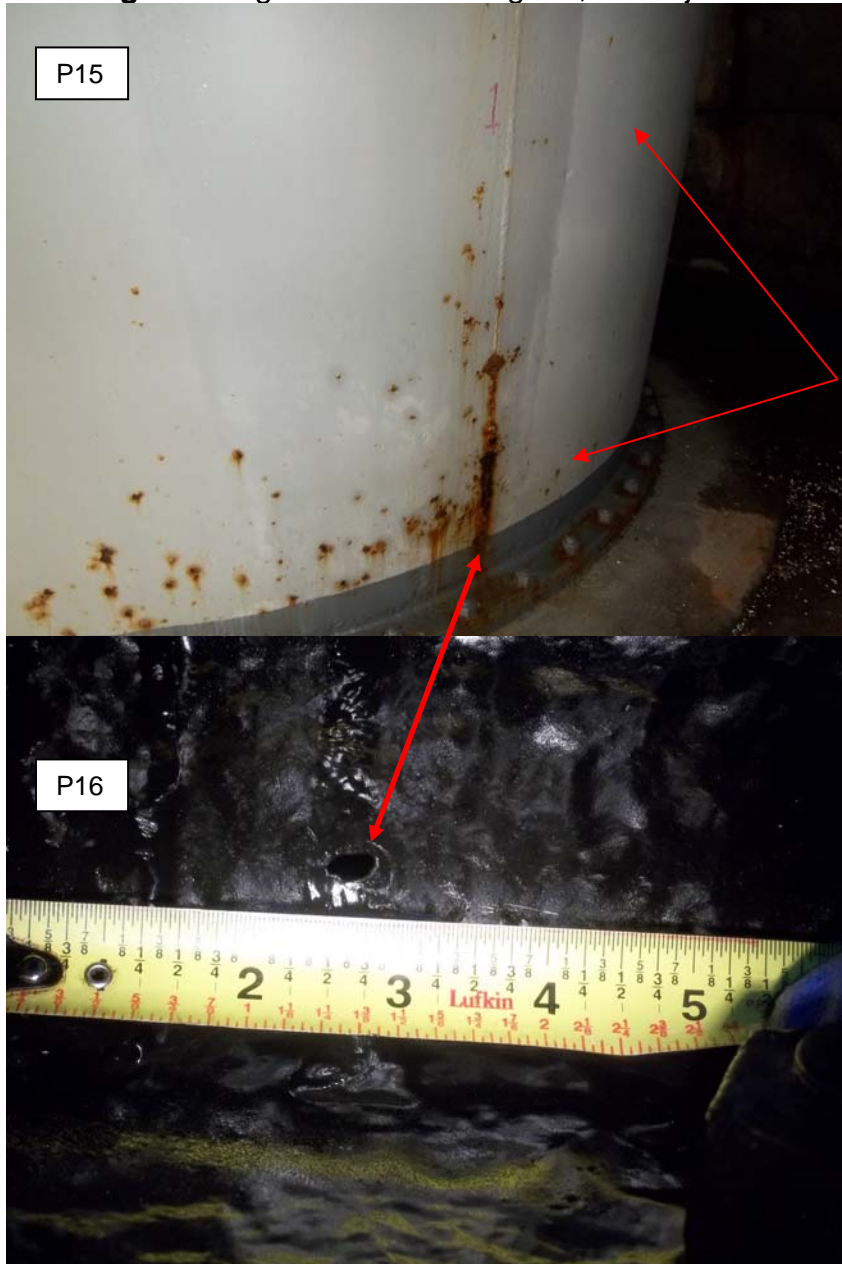
General condition of the discharge cone is fair, the outer section shown at the base area where the paint has failed, is subject to high tide flooding of 2-3 inches.

There are several deep pits including one area with a 1/2" hole. Recommend the deep pits and hole be filled with Belzona 1121 Super Repair Metal, then over coat with 5811 Immersion Grade

This part of the cone will be coated with Belzona primer 6111 and then over coated with Belzona 5811

- The components be cleaned by blasting in accordance USACE SECTION 02 82 33.13 20 for lead paint.
- All surfaces will have a SSPC-SP10 finish and primed with (**Belzona 6111**), after which two (2) coats of (**Belzona 5811**) Immersion Grade will be applied to both sides of the cone, within 3 days.
- The discharge closure will be painted with two (2) coats of (**Carboline 890 LT**) 16- 20 mils DFT total.

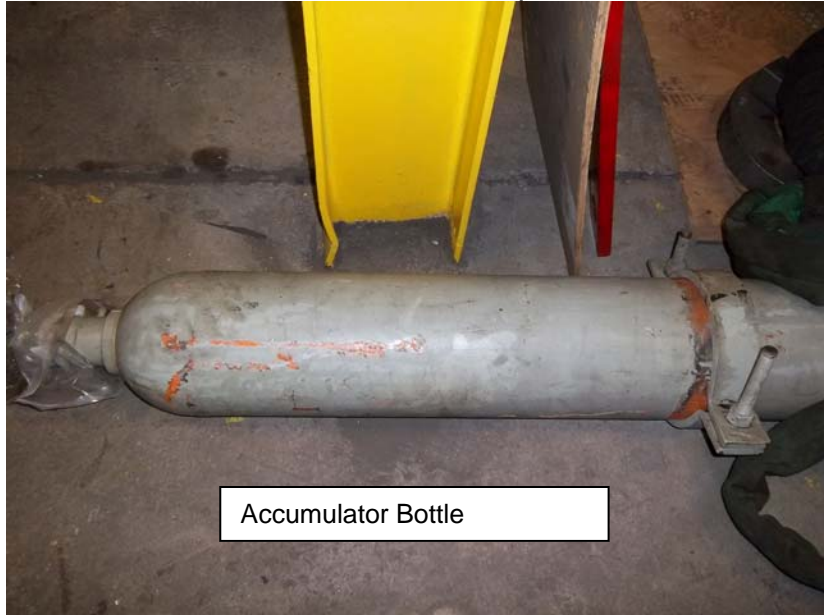
7.3.7 The three (3) backwater closure cylinder...rams (6' L) are in good condition.

The accumulator bladder was last replaced in 1997

- Rebuild each cylinder with new packing ring assemblies.
- Replace the accumulator bladder and seal kit for 10 gal unit

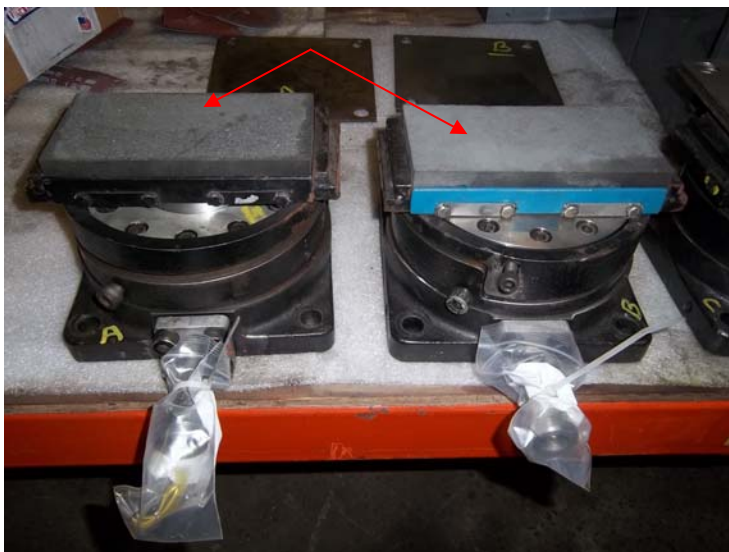
7.3.8 The four (4) anti-rotation brake units...have been disassembled and inspected all cylinders are in good condition. The packing and seal rings have been leaking hydraulic fluid. The mounting plates for securing the brake pads are bent and caused uneven wear to the brake pads.

Two of the four brakes shown after being rebuilt with new seals and resurfaced brake pads

- The brake mounting plates be straightened or replaced
- Skim cut the brake pads to be flat within .003"
- Replace with new cylinder packing in each brake

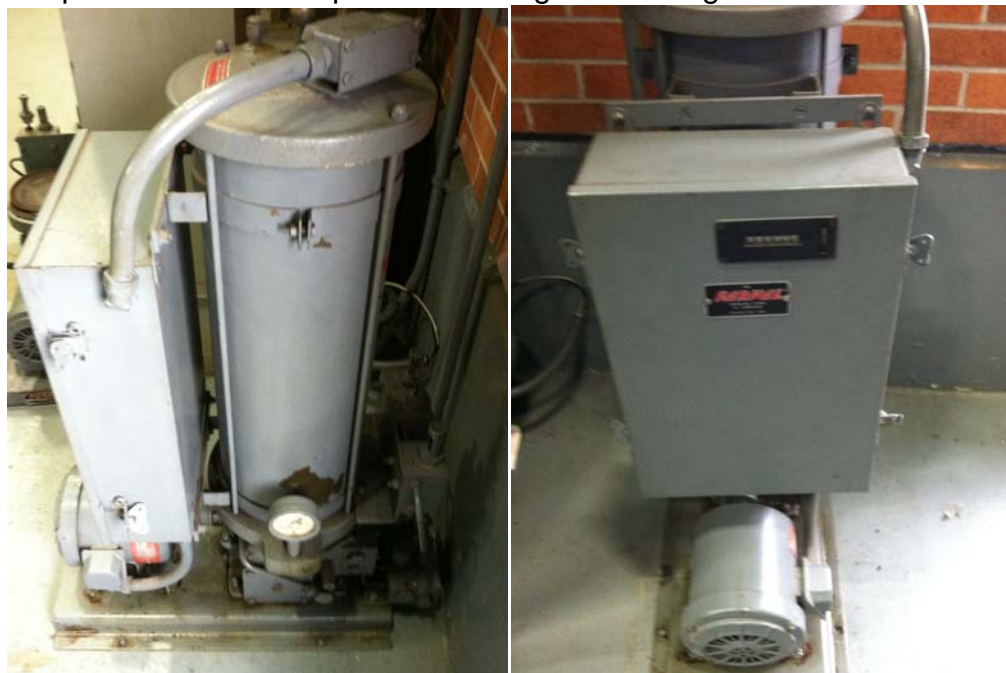
7.3.9 The Farval centralized lubrication... system provides #1NLGI grease to the upper and lower guide bearings. The upper bearing has one port in the middle and the lower bearing has two ports 180° at the top for lubricating the bearing. The unit has not been disassembled.

- Utilize the funds for inspection be applied to a new unit
- Furnish one (1) new Farval lube station, SS2200 Controller, 240/360 VAC -3 phase motor, 24# reservoir with low level switch, DR45 reversing valve, DM61 & DM62 grease valves- 3 outlets, Gauges and mounting base
