W912WJ-10-C-0013 November 2011 JC05

Condition of Unit No. 1 Worthington 119" Hi-Flo Pump, S/N 1596082

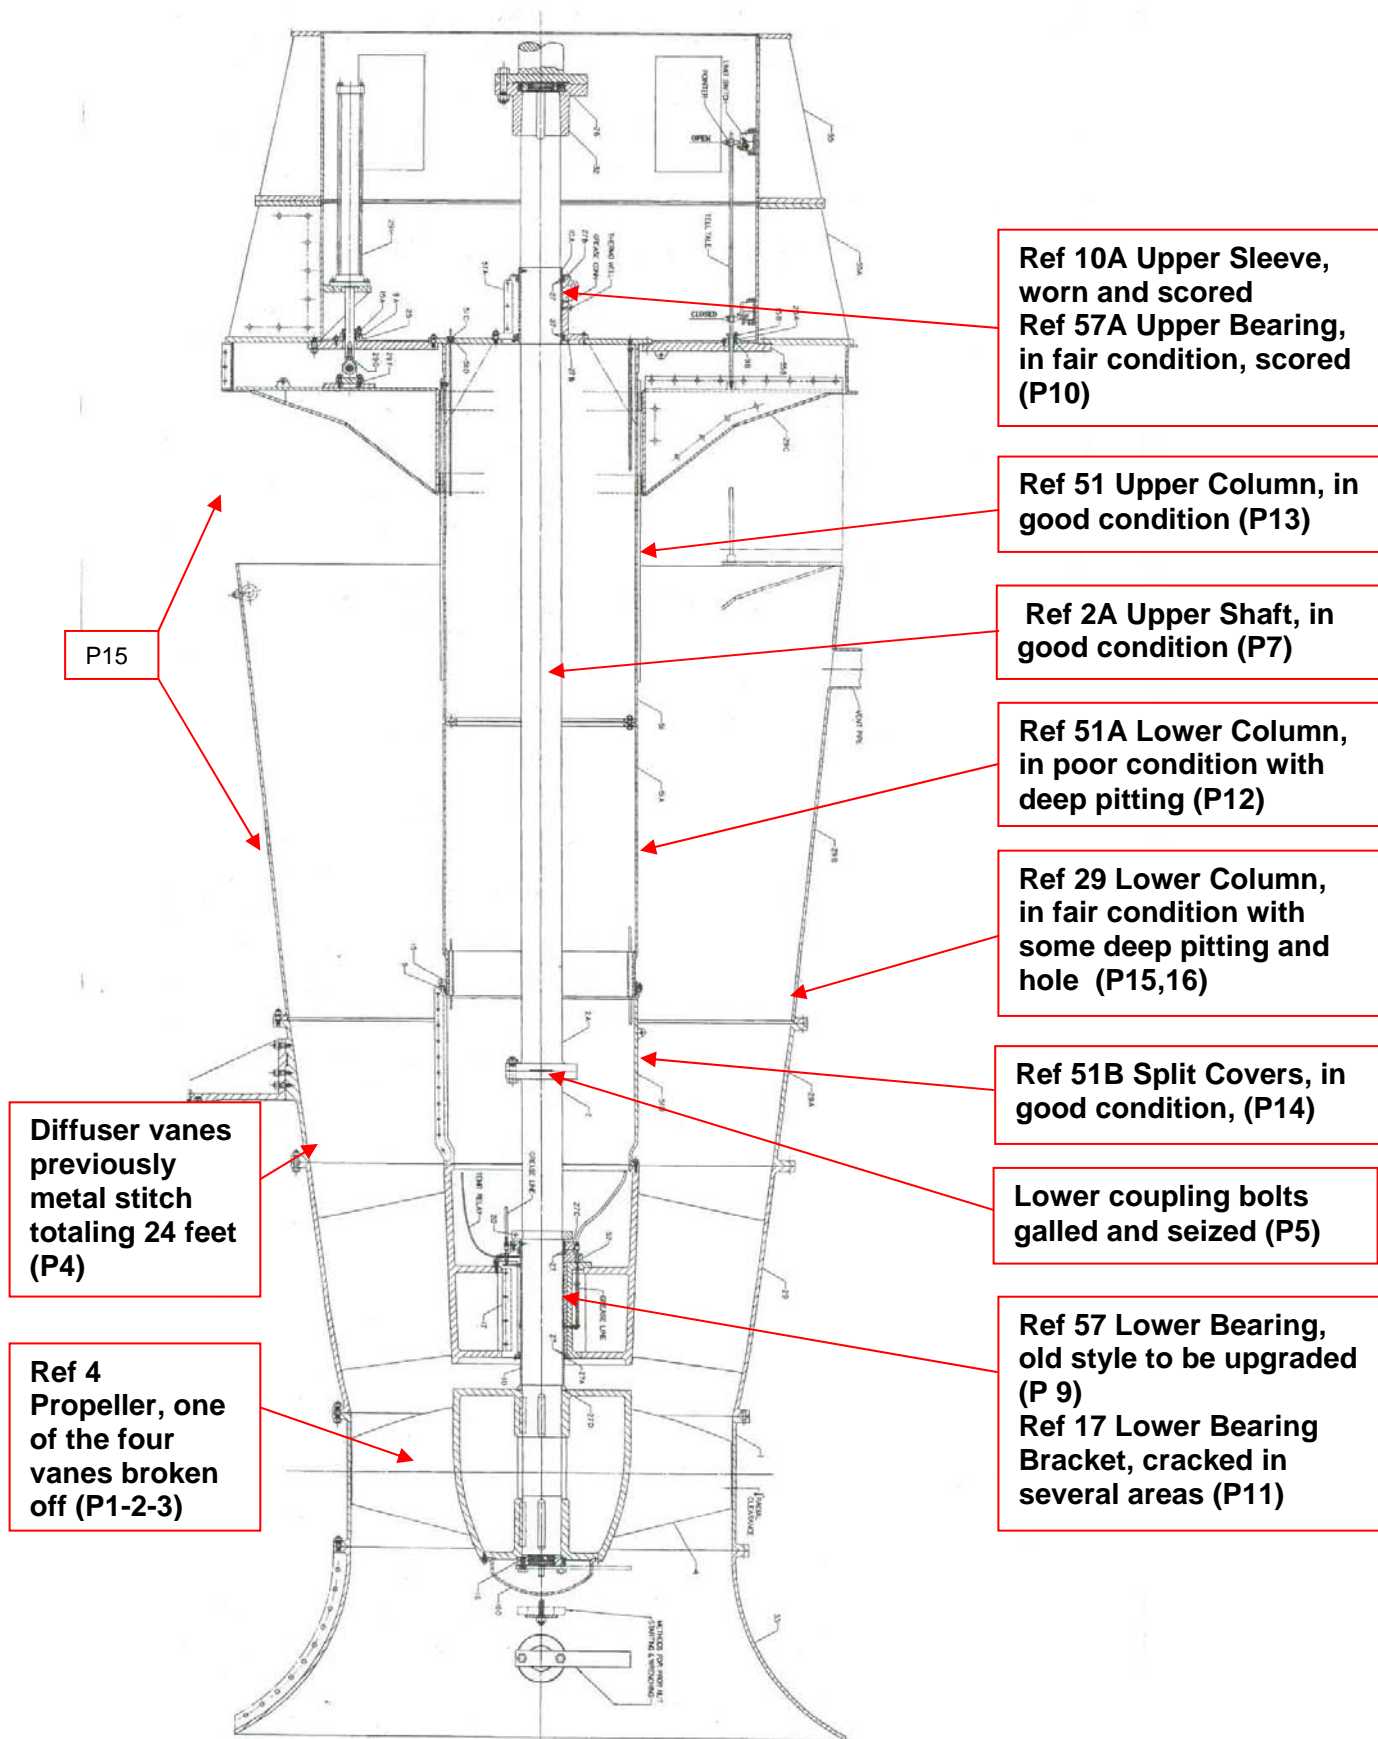
Figure 8.0

The propeller vane cracking is attributed to the type of material (NiResist Type 1b) used back in the early 60's, which did not posses enough ductility (brittle), and had long graphite flakes. Over a long period of time in usage, the many small micro-cracks in the original casting structure have greatly increased in size due residual stresses, vibration, operating impacts, etc.

Attributing failure mode...to the original material problem, we believe there was a latent defect in the casting portion of the vanes. It is not known whether this was a problem with the original hand sketch type drawings from the early 1960's before CAD was developed and then transposed into the last propellers provide in 2001 and 2005. The leading vane hub root area varies from .62" to 1.75" thick, where-as the vanes have an overall thickness of 1 .5"/2.0". This a relatively thin area at high stress point, which probably had micro cracking when originally poured due to rapid cooling at this area.

Broken blade found to the right of the suction intake area

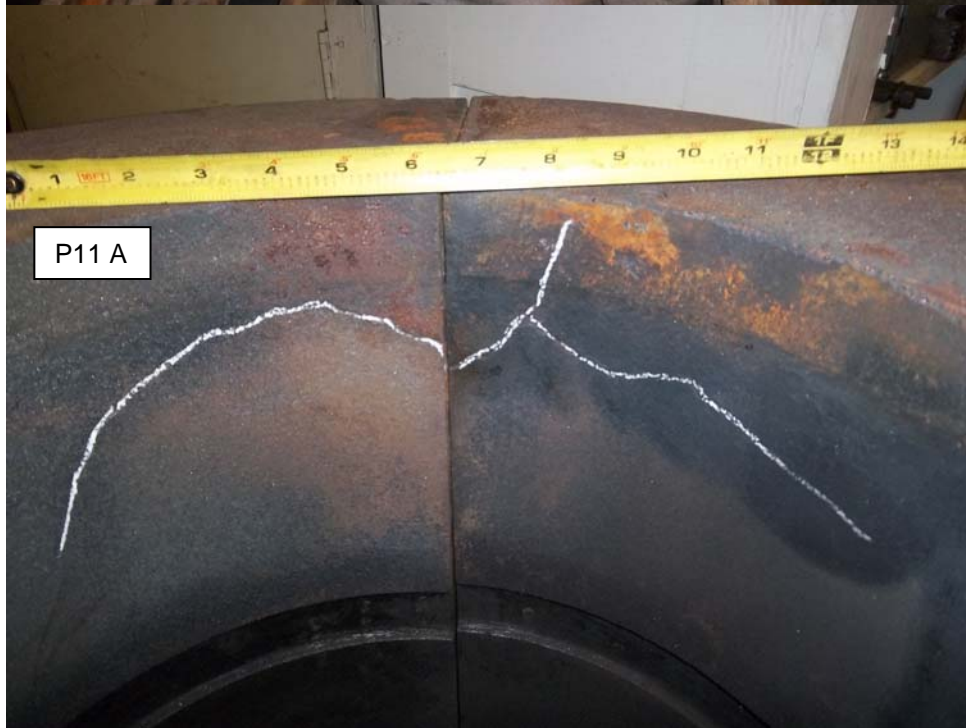
7.3.3 Lower Bearing Bracket... for mounting the lower bearing bushing and centralizing in the diffuser is in poor condition with spider cracks on both halves in the bottom area. Note previously metal stitched at other areas. Dimensional readings shown on **(Figure 8.3)**

Note the hardware was carbon steel was severely corroded.

- Furnish a new bearing bracket in Ductile Ni-Resist cast iron.
- All hardware for securing to the bearing frame be replaced in 316SS. .
- Replace the two (2) lip seals and the retainer plates with new 316SS hardware.
